# NATIONAL TERRAZZO & MOSAIC ASSOCIATION

TECHNICAL BULLETIN #T-28

## HALO effect in aggregates

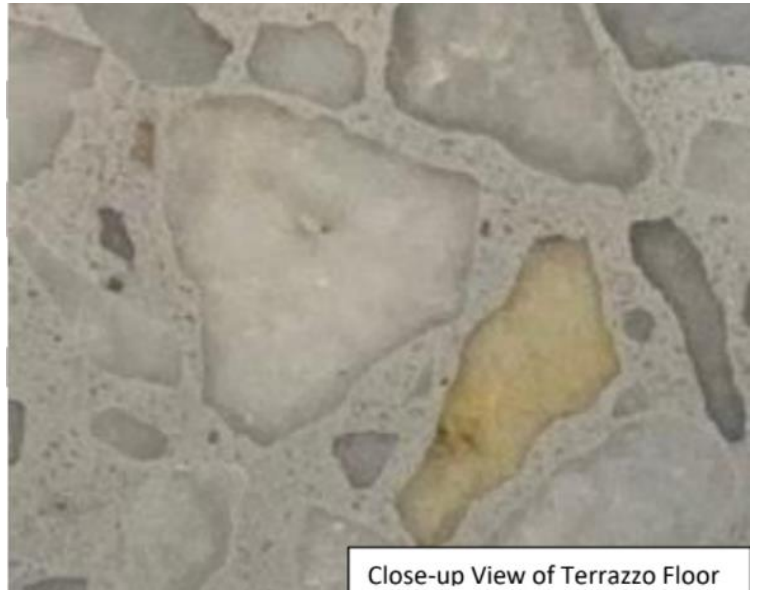
**Overview:** The terrazzo industry refers to a slight shadow or darker ring that can develop around the perimeter of aggregates (see picture) as a halo. This is typically the result of epoxy that can migrate into the stone. This phenomenon is common particularly with light color or larger Venetian aggregate.

The factor that can have a major impact is the stone itself. Some stones are softer and more porous. While it can occur in terrazzo, it is not a common problem.

**Optics:** There are no detrimental, maintenance or life cycle concerns with haloing. Since floors should be judged from a standing position, haloing should also not be an aesthetic concern to building owners and designers. Haloing is not a common issue but also is not 100% avoidable. It is most common with white marble aggregates as they tend to be more porous in nature.
