6. Random Crack Detail: For Cracks over 1/16" Width before Surface Preparation

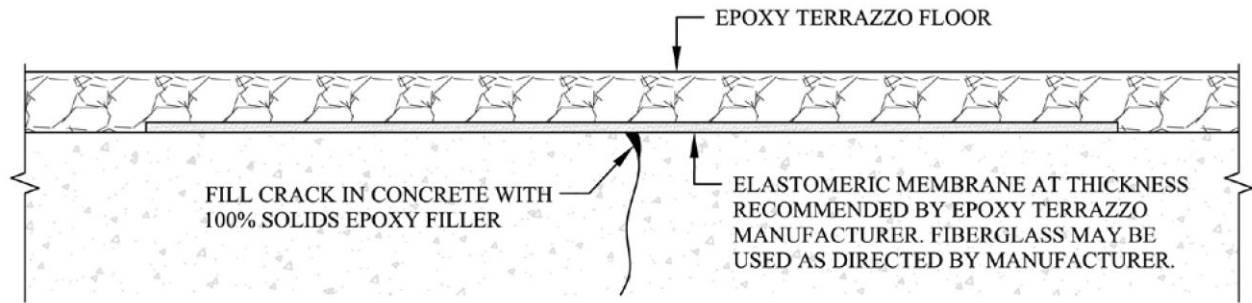
Scale: Full Scale

Treatment of cracks is in anticipation of horizontal movement.

Vertical movement will reflect through epoxy terrazzo.

Moving cracks may reflect through terrazzo, often seen under critical lighting as micro-crease or mini-mole trail, even though no actual fissure has opened, the membrane has performed as intended.
